AERONAUTICAL RESEARCH LABORATORIES

Structures Technical Memorandum 457

**A REVIEW OF AUSTRALIAN INVESTIGATIONS ON
AERONAUTICAL FATIGUE DURING THE PERIOD
APRIL 1985 TO MARCH 1987**

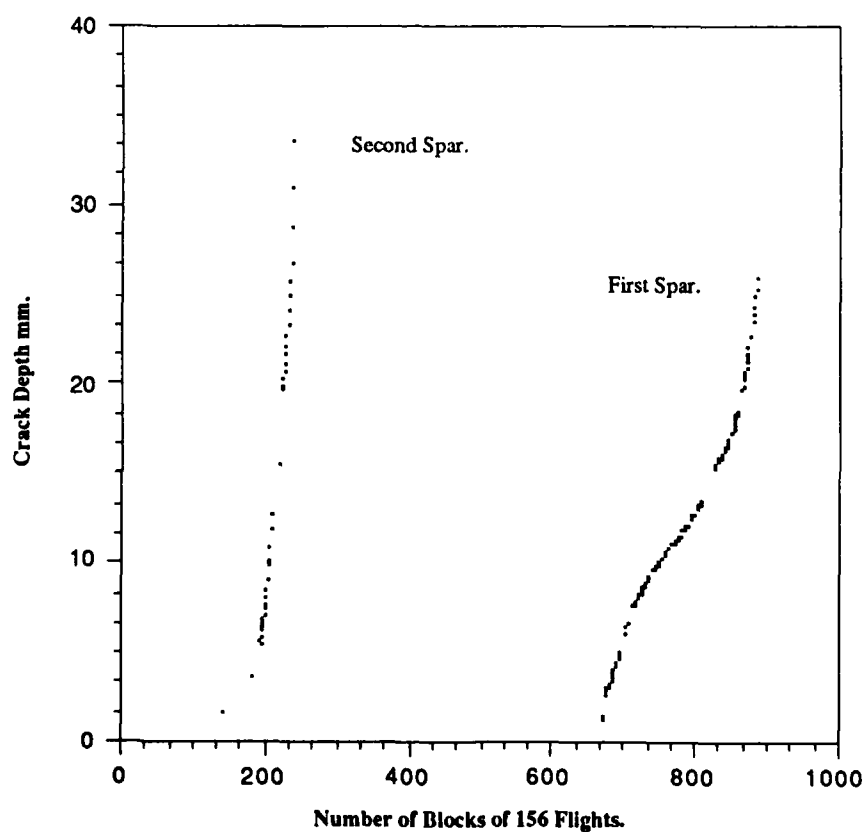
Fractographic analysis of the second spar failure, and comparison with the first, shows that the (deduced) life to crack initiation of the second failure was only about one-fifth that of the first failure, Fig. 9.2. The crack growth rates through the spar flanges for both failures were similar, but crack growth in the spar cap of the second spar was much more rapid. Although investigations to date have not revealed positively the reasons for these differences, it is noted that service stub-wing front spars were manufactured from bar, plate or extruded stock: in the case of the test article the first spar was machined from plate, the second from extrusion. Overall, the main reason for the four-fold difference in lives corresponds to the difference in crack initiation times.

FIG.9.2 FATIGUE BEHAVIOUR OF FIRST AND SECOND NOMAD STUB-WING
FAILURES AT BL 47.6

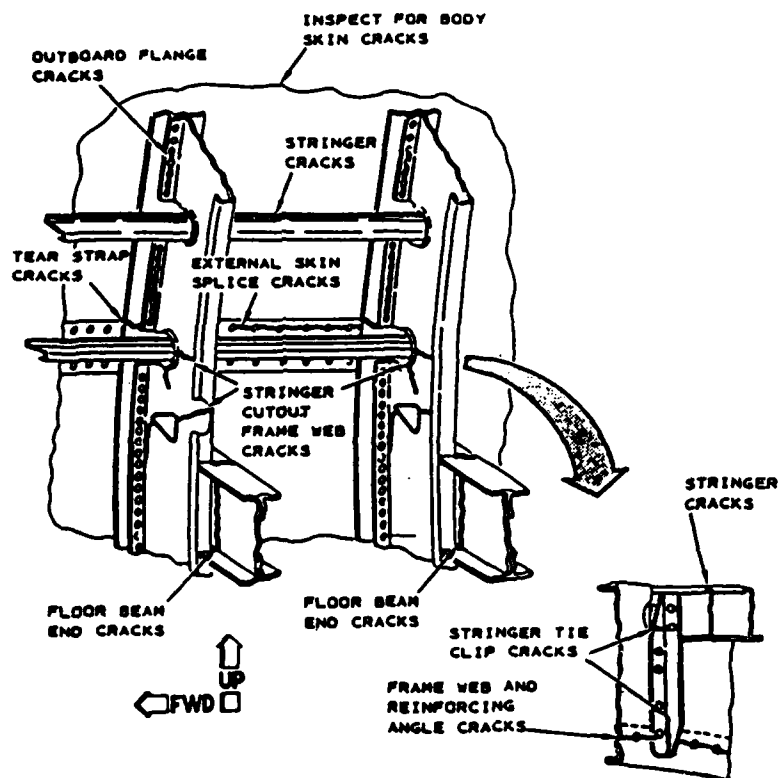
Detailed inspections by one operator on several high time 747 aircraft in late 1985 identified a large number of fatigue cracks in the forward fuselage, Fig 9.3. As a result of these inspections, additional high time aircraft were inspected to ascertain the extent of possible fleetwide cracking. One aircraft was found to have eleven frames cracked, three adjacent frames of which were completely severed. The fail-safe capabilities of the aircraft were affected by the extent of cracking being observed.

FIG.9.3 TYPICAL CRACKING IN BOEING 747 FORWARD FUSELAGE

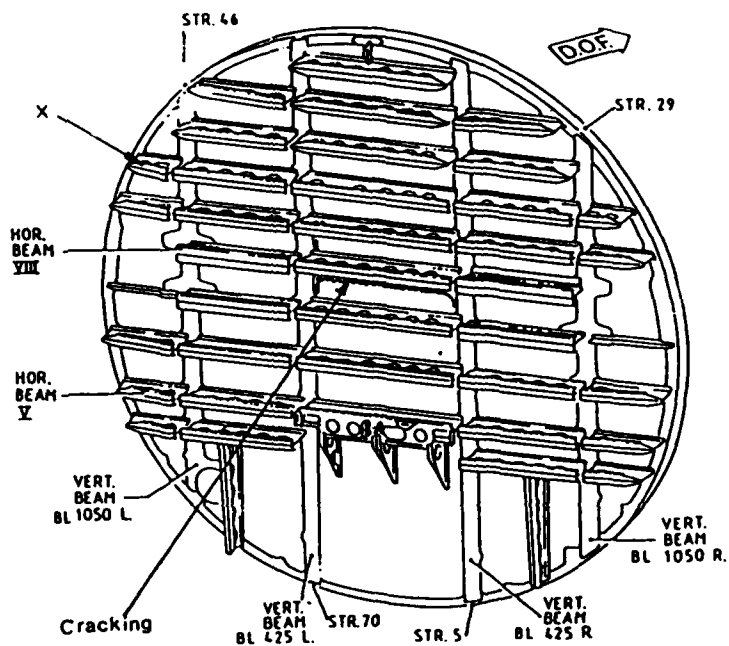
The F28 has a flat rear pressure bulkhead stiffened by vertical and horizontal beam members on its rear face, Fig. 9.4. The SIP relies on visual inspection from the rear face of the bulkhead to detect beam flange and bulkhead web cracking which result from local deflections due to pressurisation loads. Web cracking has been reported between the two rows at rivets connecting the horizontal support beams to the web, Fig. 9.5. This type of web crack is hidden by the beam when viewed from the rear face of the bulkhead, as specified in the SIP. The underlying principle behind the visual bulkhead inspection technique is that beam flange cracking and/or nicotine stains would be indicators of web cracking. In addition, since the web crack occurs between the two rivet rows, the parts of the bulkhead web remain attached to each other via the horizontal support beams thereby reducing the risk of explosive decompression. Web cracks extending beyond the SIP quoted critical crack length of 800 mm should be stopped by the vertical reinforcement beams.

The current inspection procedures were further cast into doubt by the discovery of a 530mm web crack during a major inspection. The crack was located under horizontal beam X (Fig. 9.4) between BL425L and BL1050L. The Department is currently consulting with the manufacturer on changing the SIP inspection procedures to incorporate an NDI technique for web cracking. The current visual inspection method is clearly inadequate unless inspections are extended to the front face of the web in addition to the rear face.

FIG.9.4 FOKKER F28 REAR PRESSURE BULKHEAD SHOWING CRACKING LOCATION ON AIRCRAFT SUFFERING DECOMPRESSION IN FLIGHT

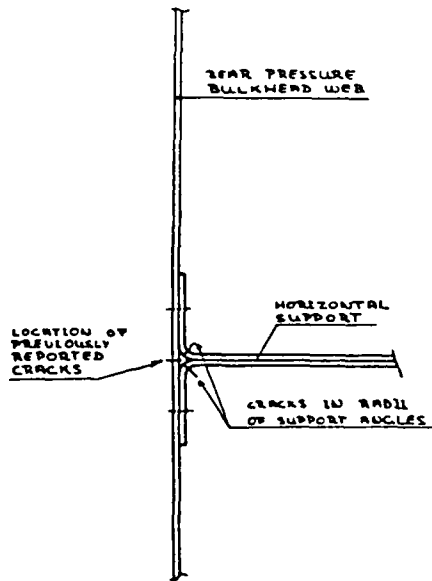
FIG.9.5 TYPICAL LOCATIONS OF F28 BULKHEAD CRACKS

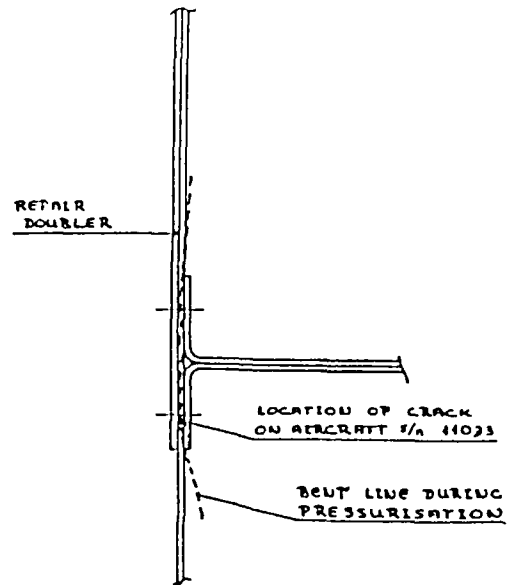
Another complicating feature of this failure is the presence of a factory-installed doubler on the front face of the bulkhead, as shown in Fig. 9.7. The doubler was installed at manufacture to rectify surface damage. The laboratory analysis revealed the presence of doubler sealant material on the fracture surface, indicating that the crack was present whilst the sealant was still fluid. The sealant indication could only occur if the sealant around the edge of the doubler had not completely set and hardened prior to cracking, in which case migration of sealant into a through-crack would be possible. This is also supported by the fact that the fracture surface at this location was the most heavily

oxidised and stained and appeared to be the first area of cracking to initiate. At the very least, the presence of sealant indicates early crack initiation and subsequent through-cracking.

The doubler installed by the manufacturer should have extended at least two rivet rows below the rivet line row attaching horizontal beam VIII (Fig. 9.7), as specified in the Structural Repair Manual. This would have produced a gradual stiffness change, as opposed to the sudden change indicated by Fig. 9.7. Whether the presence of the doubler as installed initiated the cracking is still an open question, especially considering the presence of sealant material on the fracture surface.

FIG.9.7 CROSS SECTION OF DOUBLER INSTALLATION ON F28 BULKHEAD

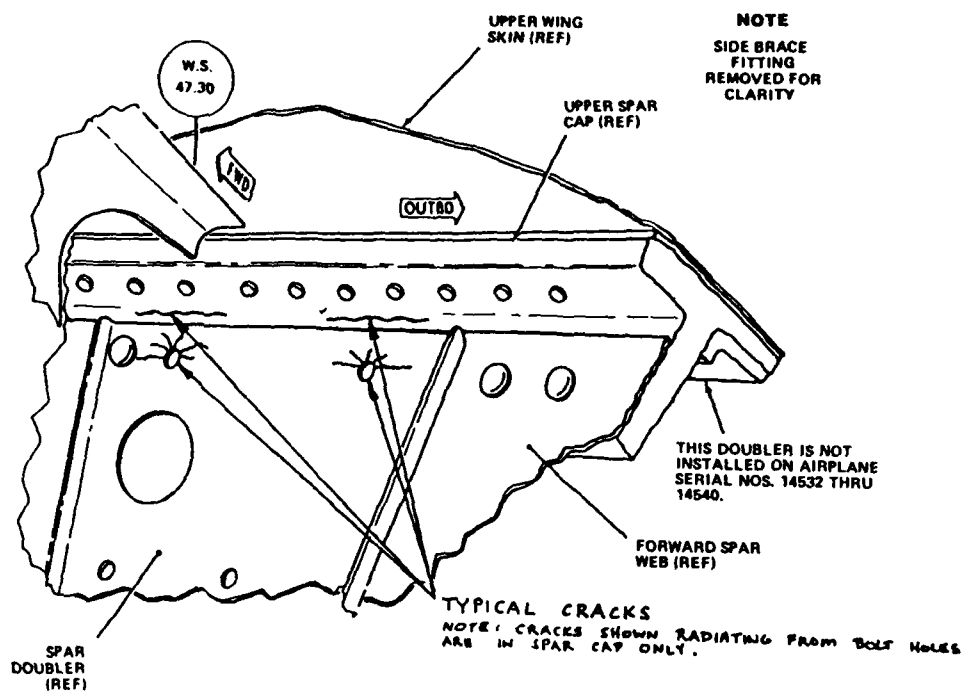
A high proportion of the Australian fleet of these aircraft has experienced cracking in the upper cap of the main wing spar, Fig. 9.8. Cracks of up to 36 mm long have been found, running spanwise in the vertical leg of the extruded T-section. This type of cracking will reduce the compressive stability of the spar cap, thereby increasing the risk of wing collapse under severe positive g manoeuvres or upgusts.

FIG.9.8 GULFSTREAM 112/114 FORWARD UPPER SPAR CAP SHOWING LOCATION OF CRACKING

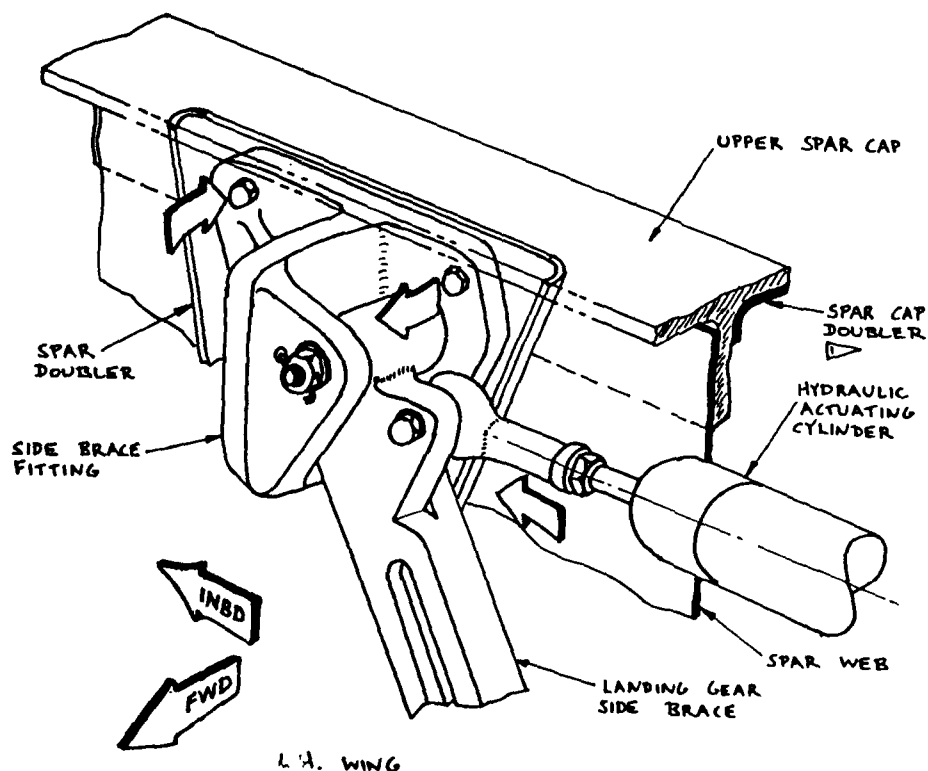
The cracking is caused by poor detail design in the method of attachment of the main landing gear mechanism. The landing gear side-brace bracket is cantilevered forward from the spar, Fig. 9.9, causing the inboard-outboard loads being reacted by the side-brace fitting during landing gear extension and retraction to produce out-of-plane bending stresses in the spar. These stresses have proved to be sufficiently high to produce cracking in some aircraft before they reach 500 hours time in service. The manufacturer's original fatigue life evaluation for the wing, by analysis only, predicted a safe life of 11,200 hours.

FIG.9.9 GULFSTREAM 112/114 MAIN LANDING GEAR SIDE BRACE FITTING SHOWING OUT-OF-PLANE BENDING LOADS APPLIED DURING GEAR RETRACTION

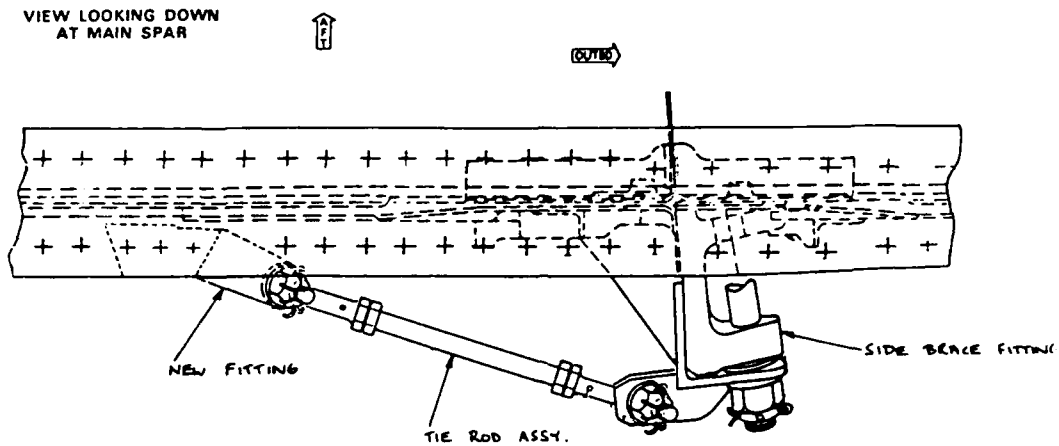
FIG.9.10 GULFSTREAM 112/114 SIDE BRACE FITTING STABILISER

The manufacturer has developed a repair and preventative modification for this problem, Fig. 9.10. The cost to owners is substantial, and the American owner's group is now taking legal action against the manufacturer.

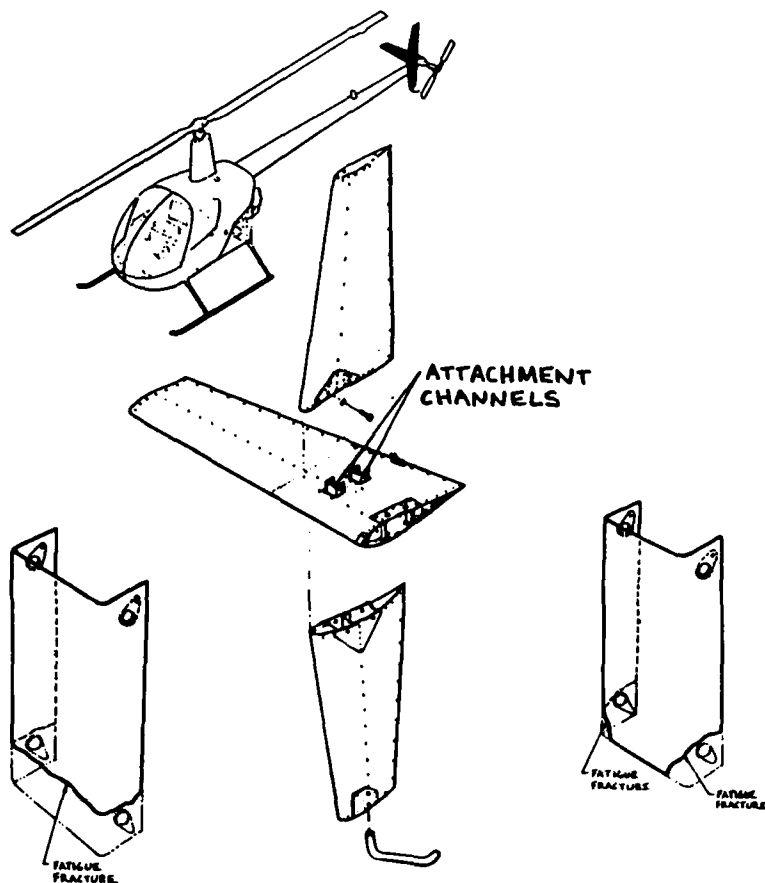
FIG.9.18 ROBINSON R22 FIN ATTACHMENT CHANNEL CRACKING

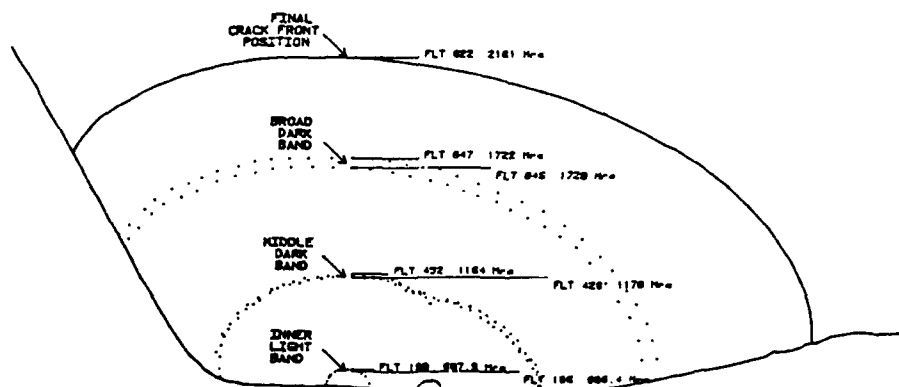
FIG.9.30 CRITICAL CRACK FROM F-111 WING PIVOT FITTING WHICH FAILED DURING COLD PROOF LOAD TESTING
